ADA TITLE II SELF-EVALUATION TRANSITION PLAN

Metropolitan Park District of Tacoma
4702 South 19th Street
Tacoma, Washington 98405

Metro Parks District of Tacoma - Transition Plan
Transition Plan – Final
Tacoma, Washington

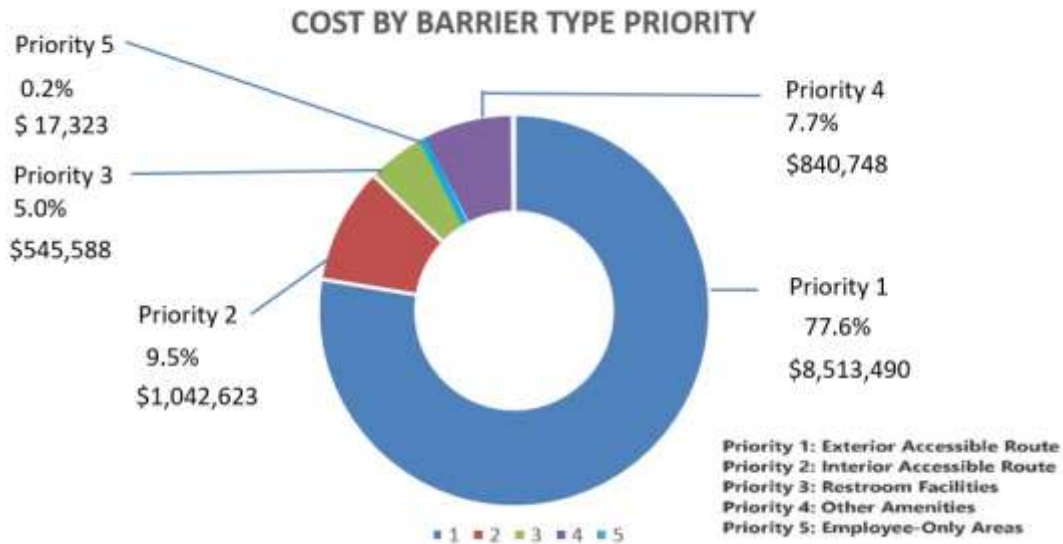
The Federal Department of Justice (DOJ) has developed guidelines so that people with disabilities should be able to arrive on the site, approach the building or park and its amenities, and enter as freely as everyone else. To meet the guidelines throughout the assessment of individual park locations, five levels of priority for barrier types were established, ranging from the exterior accessible route to a facility, the highest priority, to Employee-only areas, the lowest priority. The total cost divided over these five priorities is shown in the chart below. The greatest cost for barrier removal is Priority 1, over 77% of the total dollar amount for all barrier removals.

These priorities assigned to barrier types follow the DOJ guidelines and are built into the AssetCALC™ library. The priorities assigned to barrier types in the library provide a basic metric over which is laid prioritization based on the individual park needs for Metro Parks Tacoma properties.
